ANNUAL REPORT FOR 2000

**Mildred Woods Mitigation Site
Edgecombe County
Project No. 6.09902T
TIP No. R-2111/R-2112A**

Prepared By:
Natural Systems Unit & Roadside Environmental Unit
North Carolina Department of Transportation
December 2000

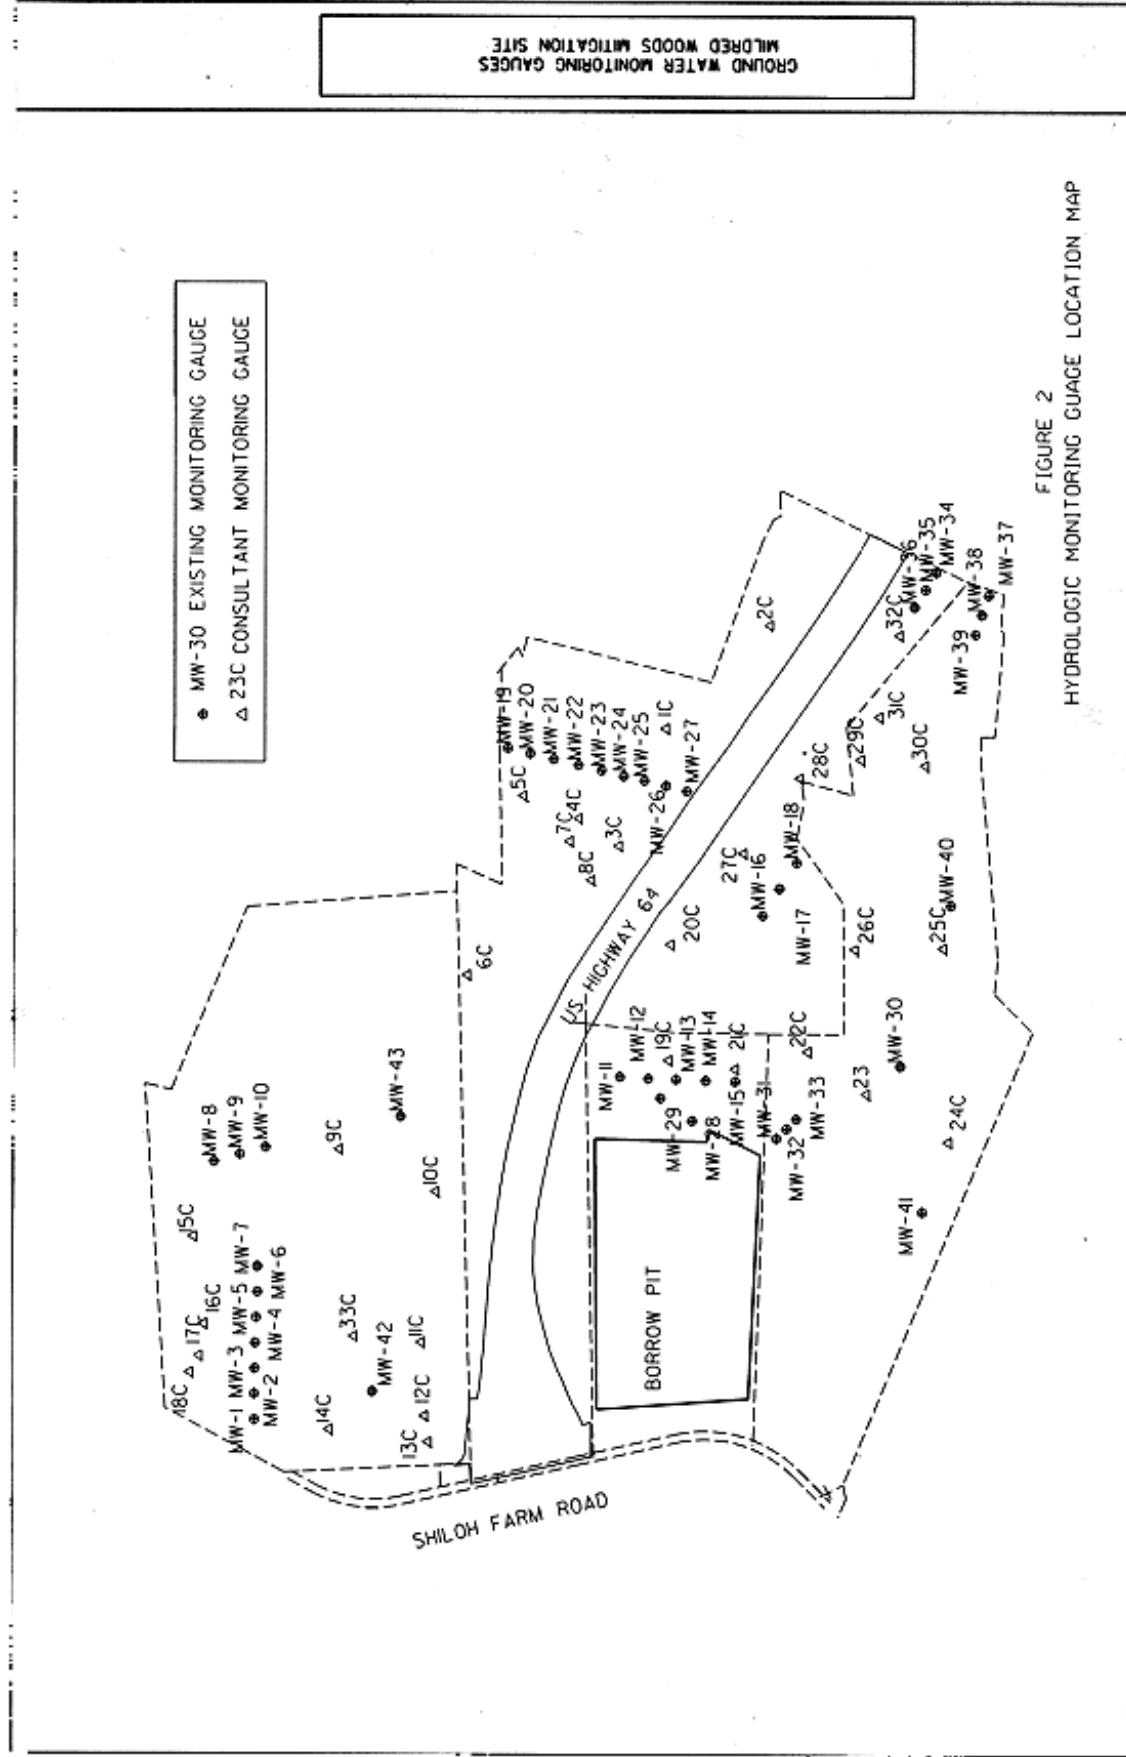
Figure 2. Hydrologic Monitoring Gauge Location Map

Forty-three monitoring gauges and two rain gauges were installed on site in between 1996 and 1998 (Figure 2). As part of the site investigation, an additional 33 monitoring gauges were installed during the month of January, prior to the start of the 1999-growing season. The automatic monitoring gauges and rain gauges record depth to groundwater and rainfall. Daily readings are taken throughout the growing season.

Because Mildred Woods is a large site, it is divided into twelve “sections”. Table 2 lists the location of each section and the gauges contained in each section. Borrow Pit 1 is located on the west side of the site. Borrow Pit 2 is located on the East Side of the site.

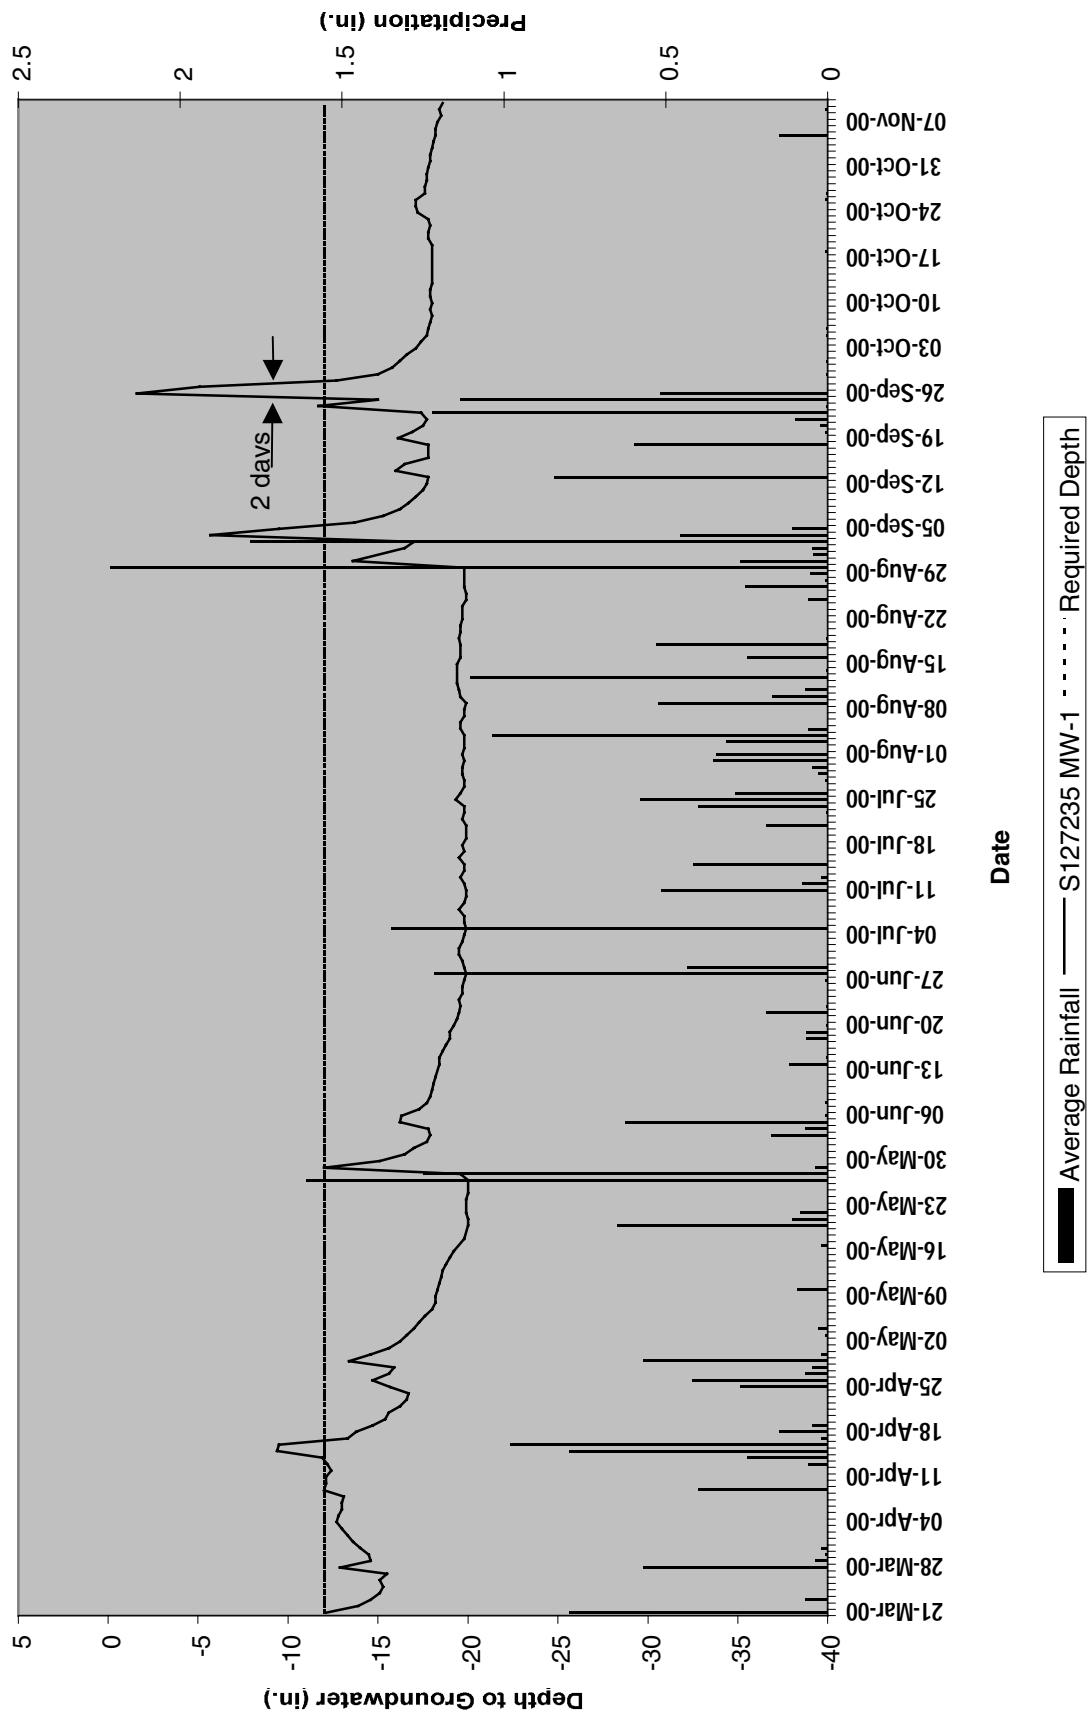
Mildred Woods MW-1

Gauge	Expected %	<5%	5% - 8%	8% - 12.5%	> 12.5%	Actual %
MW-1	≥ 12.5	✓				1.3
MW-2	≥ 12.5				✓	20.2
MW-3	≥ 12.5				✓	20.6
MW-4	≥ 12.5				✓	23.2
MW-5	≥ 12.5				✓	20.2
MW-6	$0 \leq 5$	✓				2.6
MW-7	$0 \leq 5$	✓				0
MW-15C	≥ 12.5				✓	24.9
MW-16C	≥ 12.5				✓	22.3
MW-17C	≥ 12.5				✓	27.9
MW-18C	≥ 12.5				✓	21.9

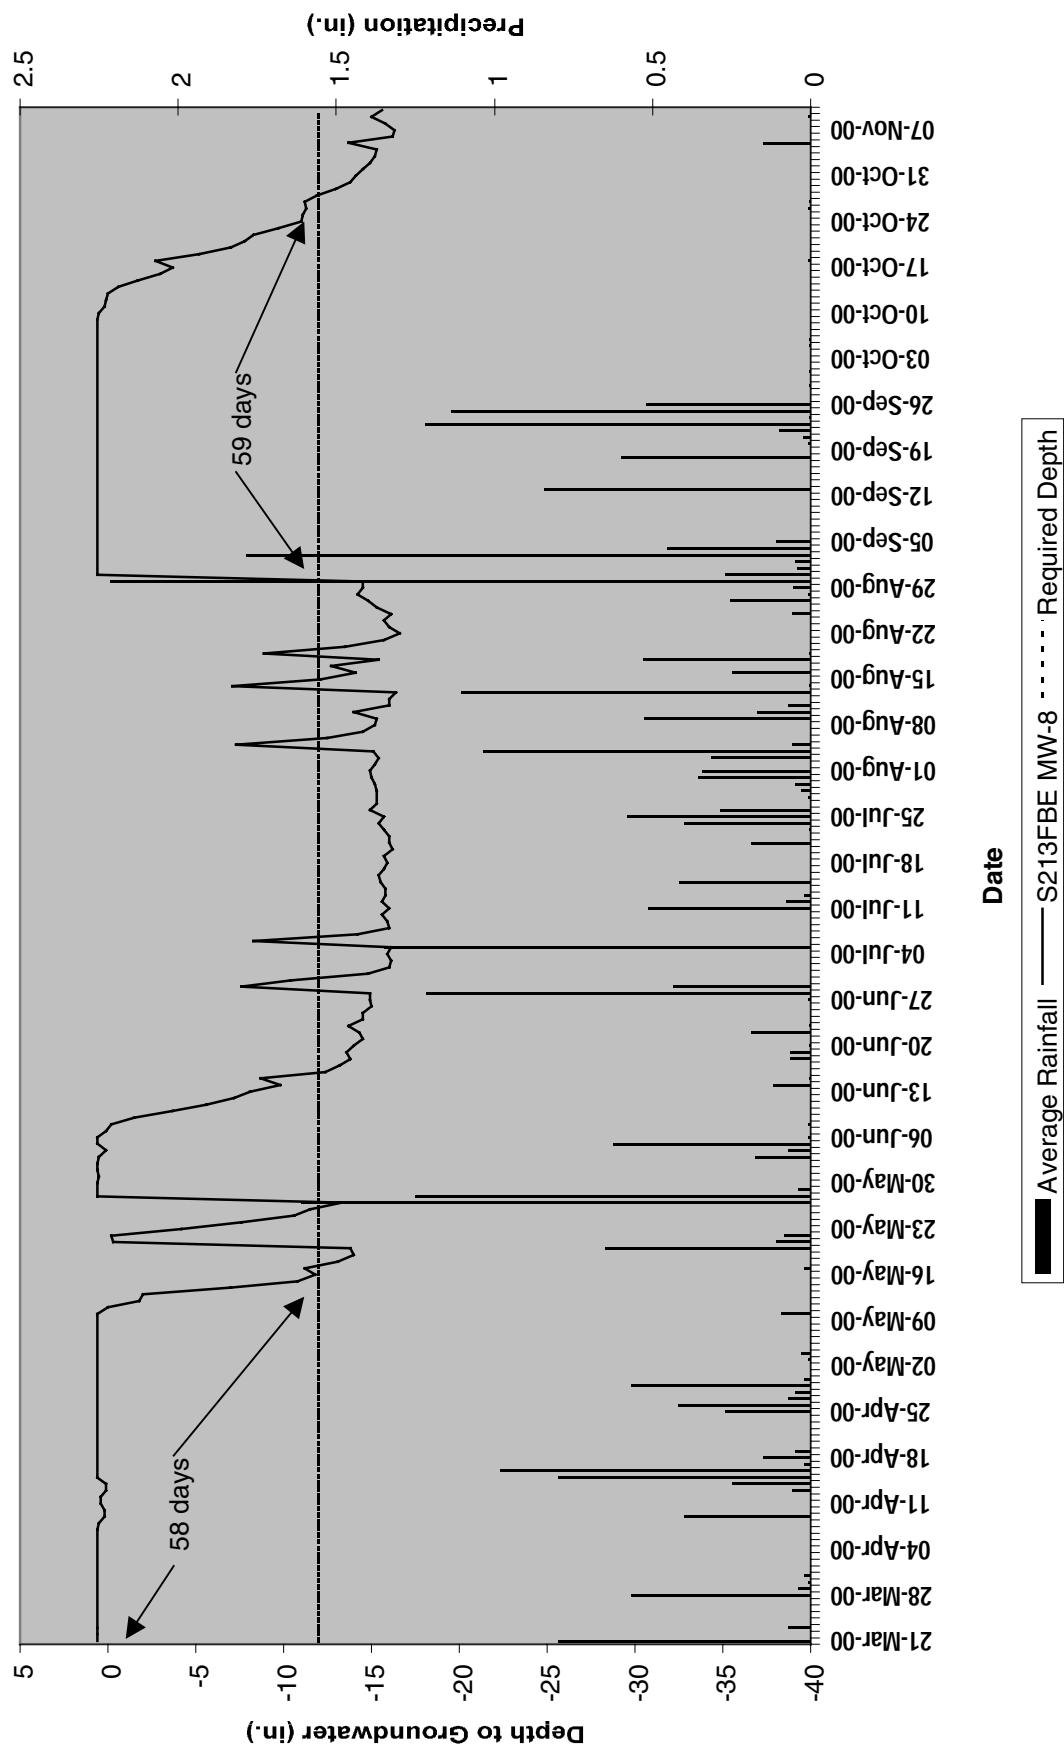
Mildred Woods MW-8

Gauge	Expected %	<5%	5% - 8%	8% - 12.5%	> 12.5%	Actual %
MW-8	≥ 12.5				✓	25.9
MW-9	≥ 12.5				✓	20.6
MW-10	$0 \leq 5$	✓				3.9

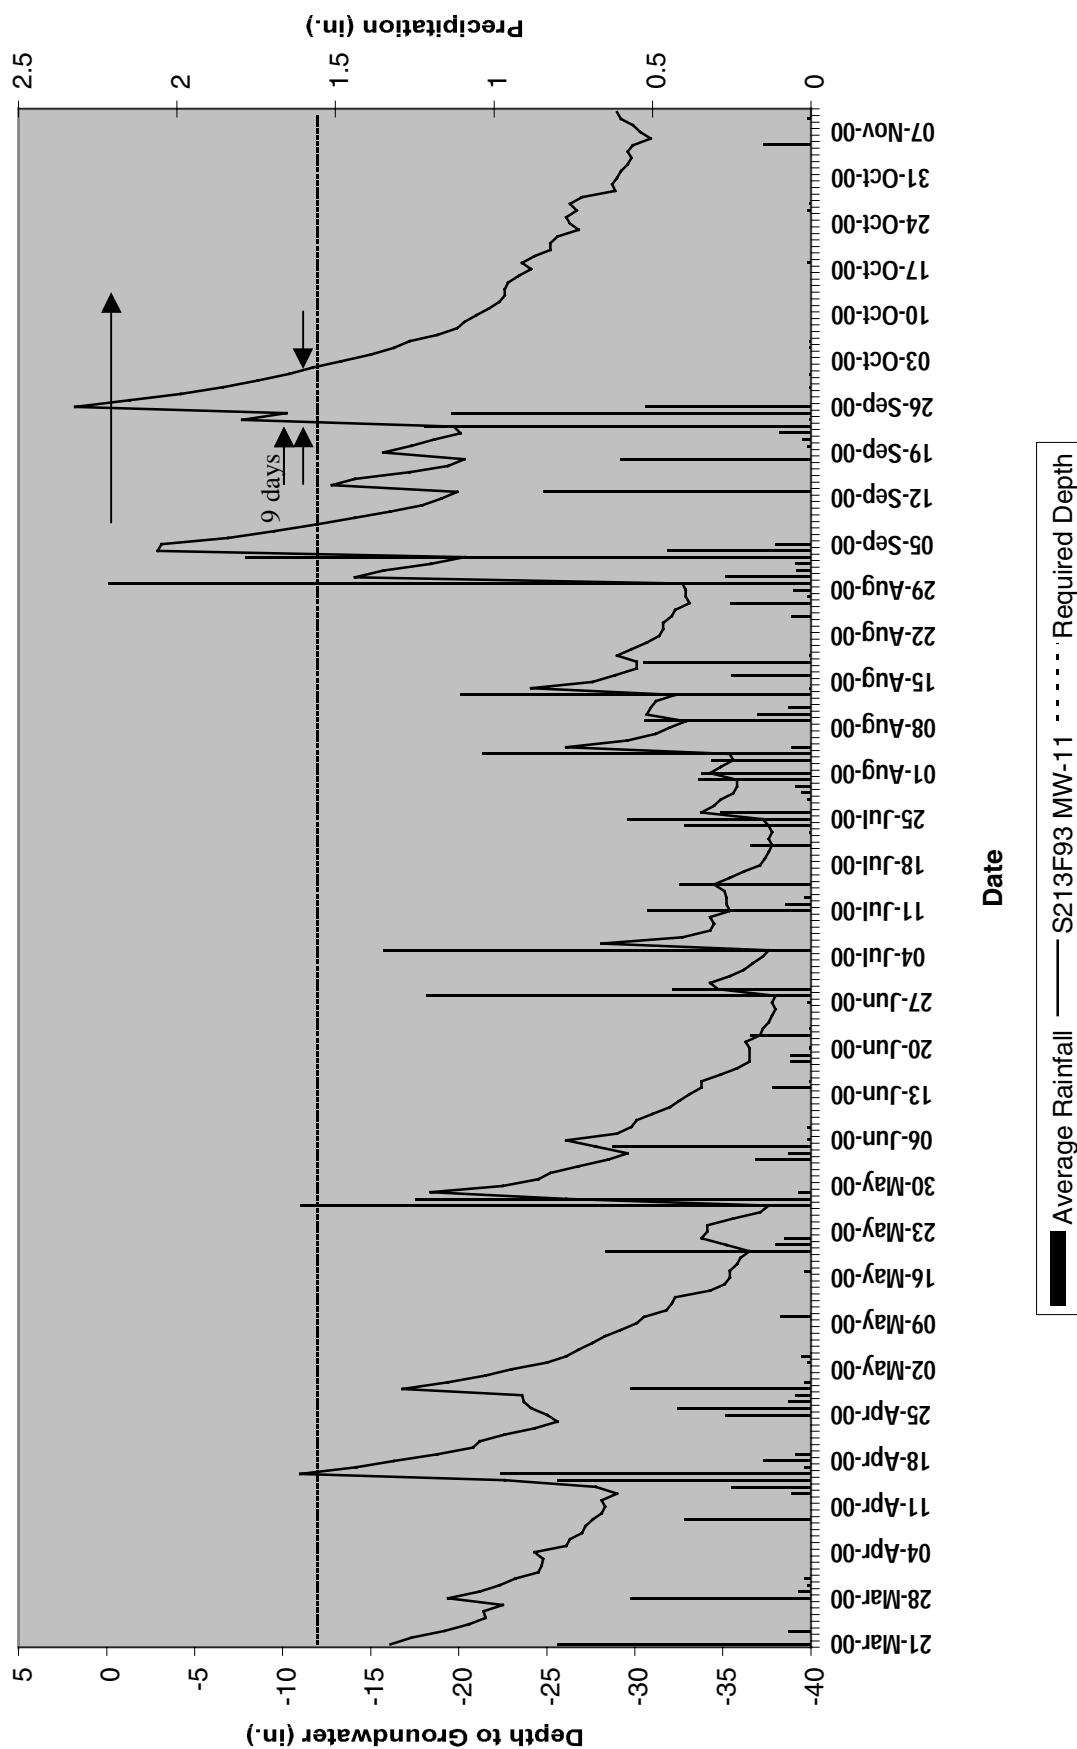
Mildred Woods MW-11

Gauge	Expected %	<5%	5% - 8%	8% - 12.5%	> 12.5%	Actual %
MW-11	≥ 12.5	✓				3.9
MW-12	≥ 12.5	✓				3.4
MW-13	≥ 12.5				✓	30.9
MW-14	≥ 12.5	✓				0.9
MW-15	≥ 12.5	✓				4.3
MW-19C	$5 \leq 12.5$		✓			6.0
MW-21C	≥ 12.5	✓				2.6

Only two of the seven gauges in the center section met the expected hydrology.

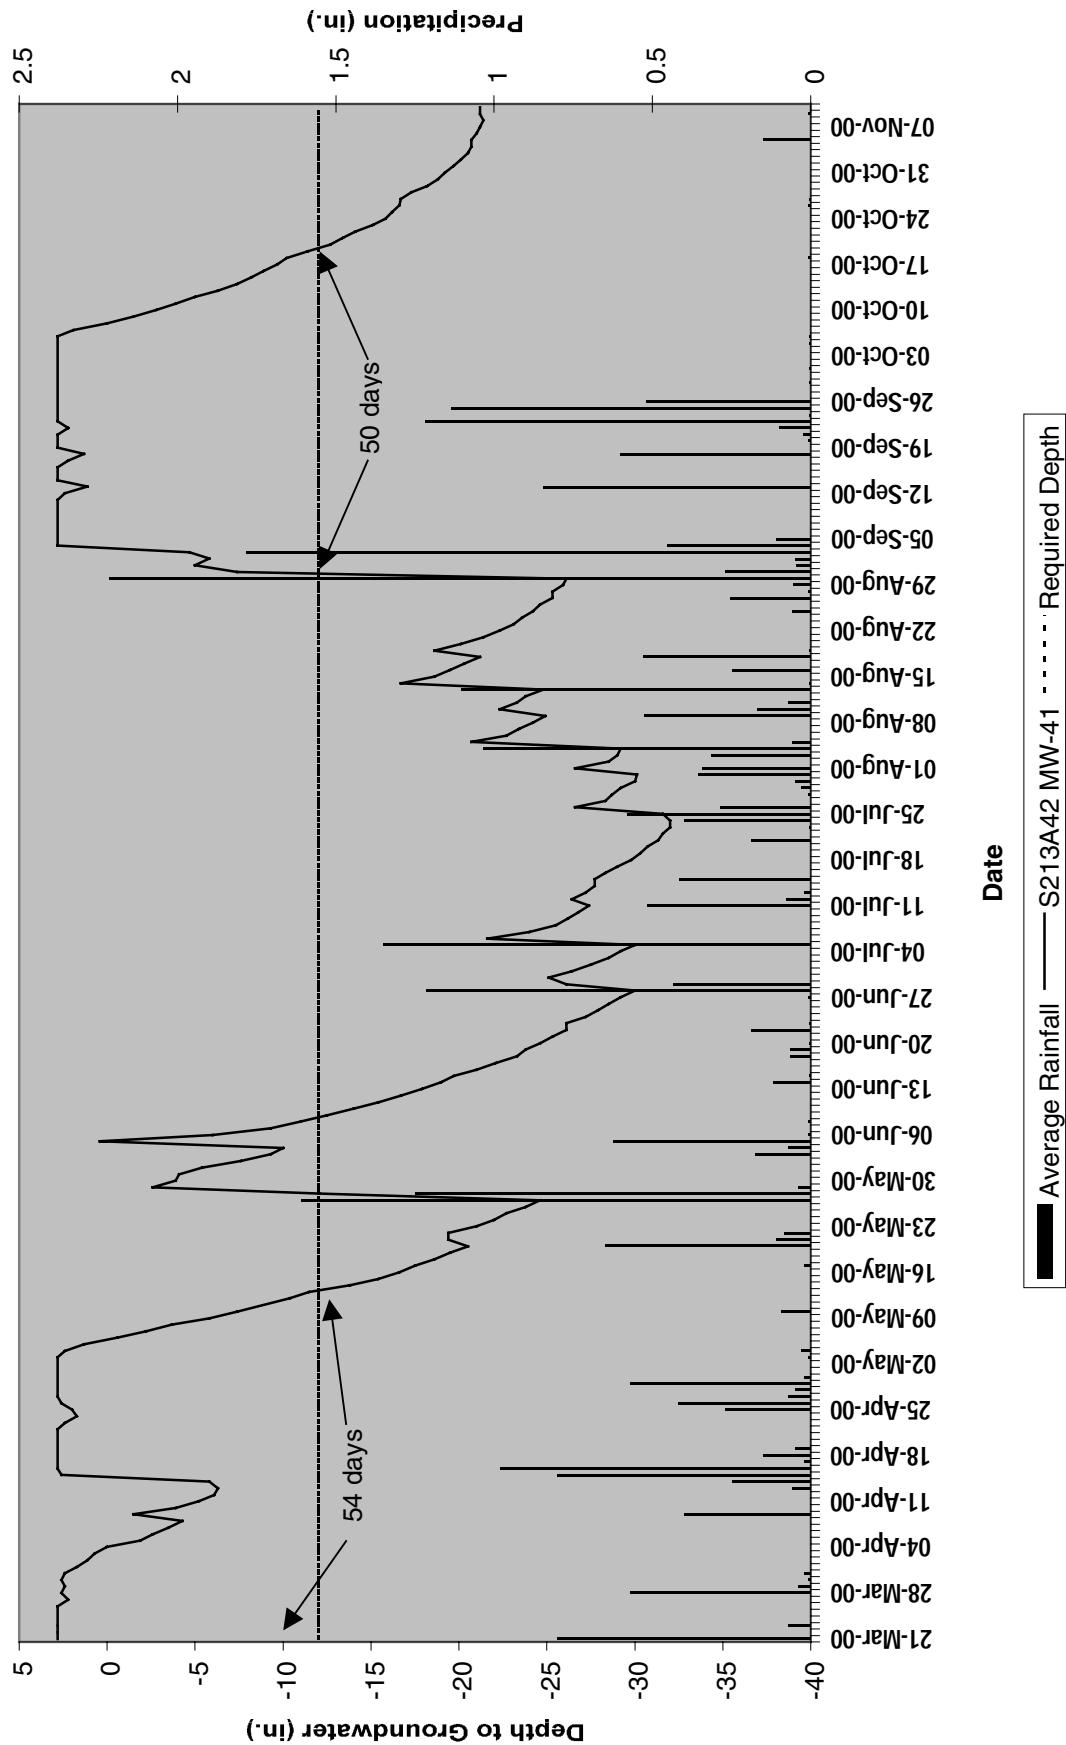
Mildred Woods MW-41

Gauge	Expected %	<5%	5% - 8%	8% - 12.5%	> 12.5%	Actual %
MW-41	0 ≤ 5				✓	23.2
MW-24C	5 ≤ 12.5	✓				1.3

One of the two gauges south of borrow pit 1 greatly exceeded its expected hydrology, which was to show saturation for less than 5% of the growing season.
